<b>IP TEST REPORT</b>	
Report reference number: MTEX 1082/20.0266	
Date Tested:	17/08/2020
Date Report was issued:	21/08/2020
Standards.....:	SANS 60529:2013 "Degree of protection provided by enclosure (IP Code)."
IP rating obtained after testing:	IP43
Applicant's Company Name .....	POWER PROCESS SYSTEMS
Applicant's reference.....:	COD
Device.....:	Pole Mount Enclosure Polyethylene
Address.....:	P.O. BOX 4172 SOUTHGATE 2082
General remarks: The test results presented in this Test Report relate only to the item or product tested. <ul style="list-style-type: none"> <li>▪ "(see Attachment #)" refers to additional information appended to this document.</li> <li>▪ "(see appended table)" refers to a table appended to this document.</li> <li>▪ Throughout this document, a point "." is used as the decimal separator.</li> </ul> This report/certificate shall not be reproduced except in full.

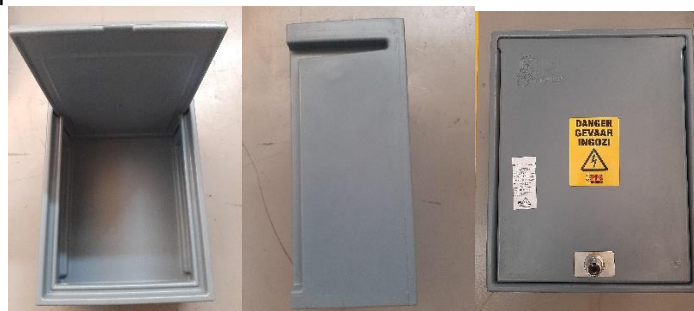
The enclosure was manufactured from grey Linear Low-Density Polyethylene (LLDPE) moulded non-metallic material. The door of the enclosure was fitted to the enclosure without any hinges, and slide into the top part of the enclosure to stay in the open position. The enclosure made provision to be locked by means of a hexagon head bolt protruding through the bottom part of the door.

The enclosure had approximate dimensions of 470mm x 370mm x 200mm.
